SPE 68789

## Preventive Maintenance of Electric Submersible Pumps and its Relationship to Root Cause of Failure Analysis

W.A. Limanowka, SPE and S. Degen, Canadian Advanced Submersible Pump, and G. Benwell, Tusk Energy Inc.

This paper was prepared for presentation at the SPE Western Regional Meeting held in Bakersfield, California, 26–30 March 2001.

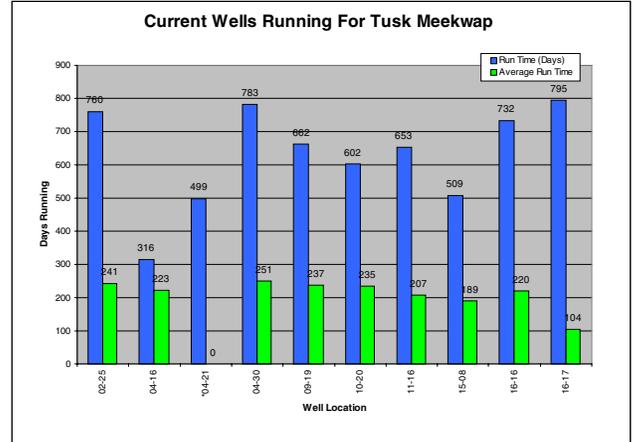
Now ESP run times are exceeding 600 days (see graph 1), causing a decrease in lost production of 2000 bbl/day

Previously, ESP run times were averaging 200 days, resulting in approximately 12 days of lost production per year per well for a total of 3000 bbl oil.
